# Your Personal Home Inspection

123 Somewhere Street  
Yourtown, US 12345

Prepared for: Bob Client

Prepared by: Downriver Home Inspections  
1234 Company Lane  
Somewhere, US 12345

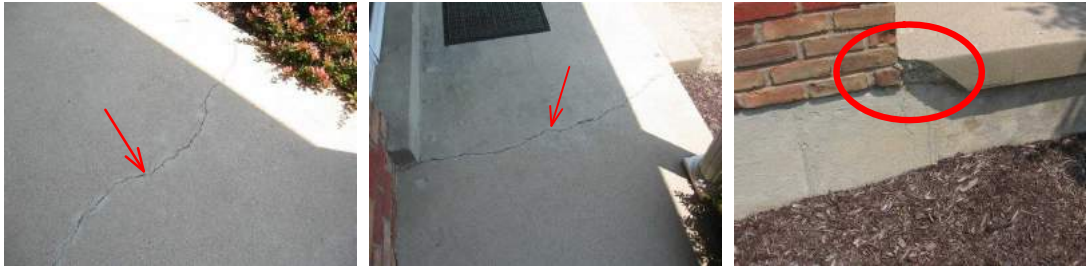
- 1.      Driveway: Concrete
- 2.      Walks: Concrete
- 3.      Porch: Concrete **Settling away from foundation with surface cracks noted**

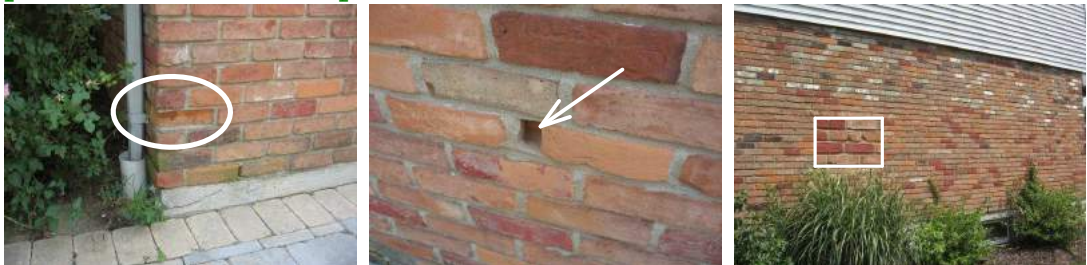
- 1.      Type: Brick veneer **Some damaged bricks, Recommend sealing brick with penetration sealer products**

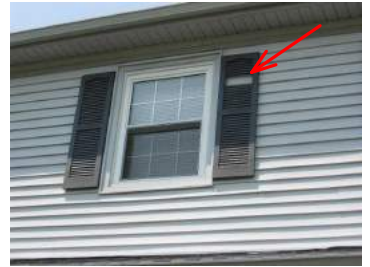
2.      Type: Vinyl siding Damaged front shutter, Chalking noted due to age, One panel needs to be repositioned at rear elevation

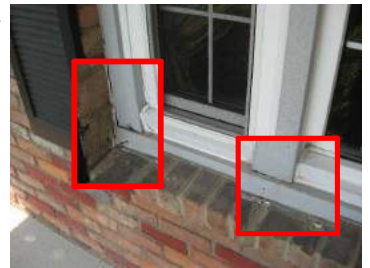
3.      Trim: Aluminum Chalking noted due to age, Loose nails in areas  
4.      Fascia: Aluminum  
5.      Soffits: Vinyl Loose/sagging at front porch  
6.      Door Bell: Hard wired  
7.      Entry Doors: Wood  
8.      Patio Door: Vinyl sliding Resecure loose handle hardware, Screen damage noted  
9.      Windows: Vinyl insulated Reseal caulking at window perimeters at brick window openings

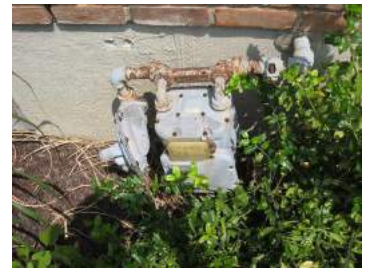
10.      Window Screens: Metal  
11.      Basement Windows: Vinyl casement  
12.      Exterior Lighting: Surface mount  
13.      Exterior Electric Outlets: 110 VAC GFCI  
14.      Hose Bibs: Gate Properly secure fixture(s) to exterior wall with fasteners  
15.      Gas Meter: Exterior surface mount at side of home Rust present, Keep bushes and shrubs away from meter

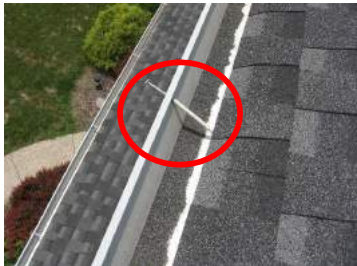
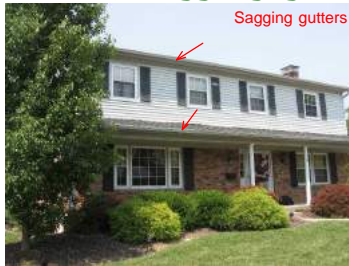
- 2.      Unable to Inspect: 0%
- 3.      Material: Fiberglass shingle
- 4. Type: Gable
- 5. Approximate Age: 5
- 6.      Flashing: Metal
- 7.      Plumbing Vents: Copper
- 8.      Electrical Mast: Underground utilities
- 9.      Gutters: Aluminum **Loose nails, Sagging gutters at front and rear**

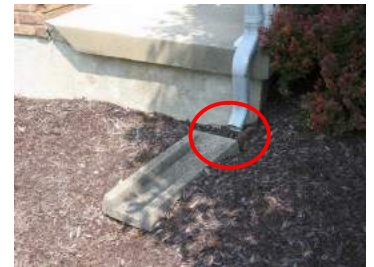
- 10.      Downspouts: Aluminum
- 11.      Leader/Extension: Splash blocks **Splash block(s) not properly installed**

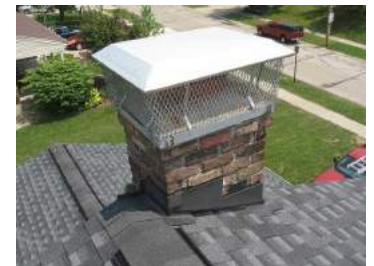
- 12.      Chimney: Brick
- 13.      Flue/Flue Cap: Clay tile Weather cap obstructed view of flue

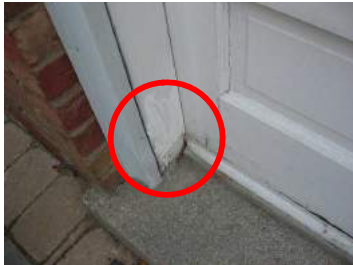
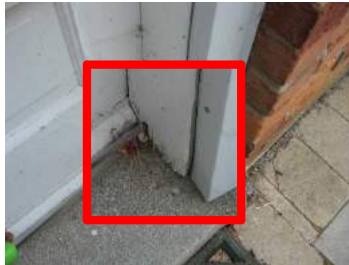
8.      Service Doors: Wood **Wood rot at bottom of door and frame**

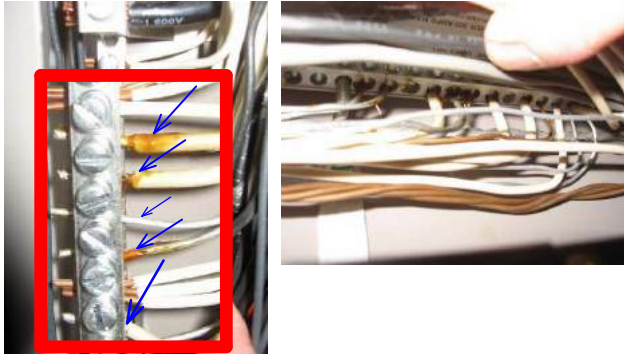
1. Service Size Amps: 200 Volts: 120/240 VAC
2.      Service: Aluminum
3.      120 VAC Branch Circuits: Copper and aluminum *Evaluation by a licensed electrician is recommended, See aluminum wiring notes below*

4.      240 VAC Branch Circuits: Copper
5.      Aluminum Wiring: Present at several circuits *Aluminum branch wiring has had a history of problems relating to poor connections due to galvanic corrosion, dissimilar metals, brittle conductors and type of aluminum alloy used during the time period of 1965 through 1972. These problems create unsatisfactory conditions at connections and splice locations and therefore create potential fire hazards. Recommend wiring update for aluminum wiring by a licensed electrician, Circuits are recommended to be upgraded with special compression type connectors at splices and branch circuits to reduce the potential risks of aluminum branch wiring. (Cop-Alum Crimp System)*

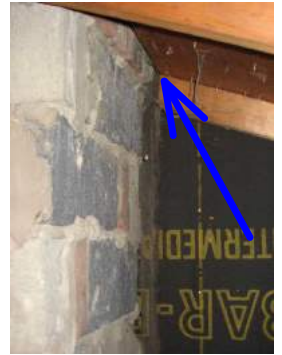
- 1. Method of Inspection: In the attic
- 2.      Unable to Inspect: 15% Safety and footing
- 3.      Roof Framing: 2x3/4 Truss Wood blocking components missing at chimney perimeter

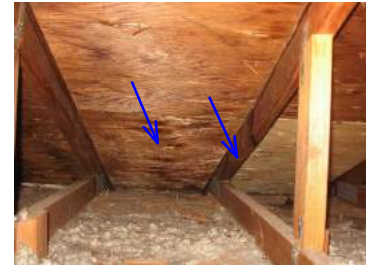
- 4.      Sheathing: Plywood Water stains and slight damage present, Areas of sheathing have been repaired

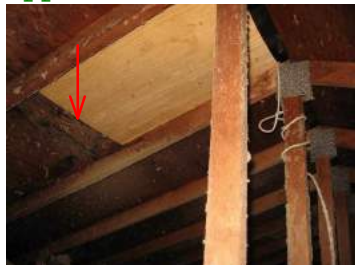
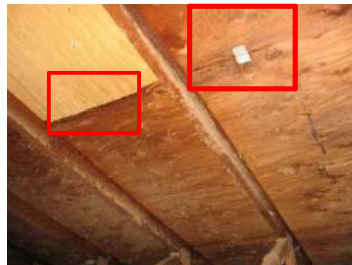
- 9. Method of Inspection: In the attic
- 10.      Unable to Inspect: 10% Safety and footing
- 11.      Roof Framing: 2x3/4 Truss
- 12.      Sheathing: Plywood Poor repair at 2 areas near ridge at rear slope - No H clips installed and repair only spanned one truss - Recommend additional support be installed

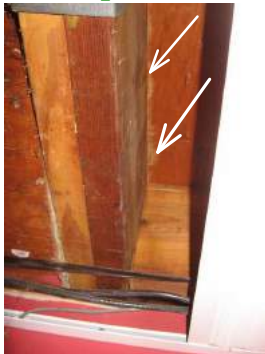
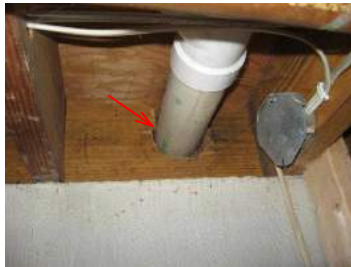
- 1.      Structure Type: Wood frame
- 2.      Foundation: Poured concrete
- 3.      Differential Movement: Slight settlement present Minor settlement at front porch, Cracks will require monitoring
- 4.      Beams: Steel I-Beam
- 5.      Bearing Walls: Wood frame
- 6.      Joists/Trusses: 2x10 Areas not visible due to ceiling finishes or other obstructions, Framing joist near fireplace chimney shows evidence of previous termite infestation - No repairs required, Seal penetration as required

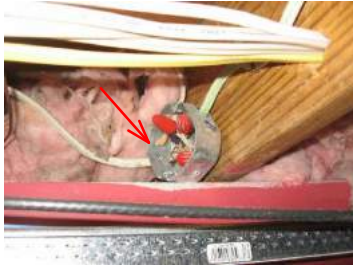
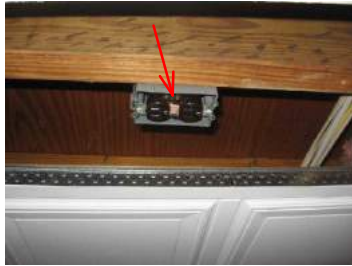
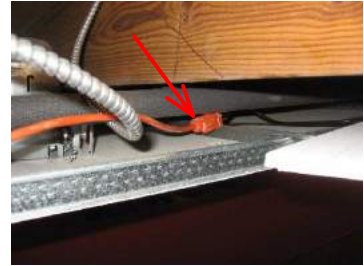
- 2.      Ceiling: Suspended Acoustical System Evidence of past water staining
- 3.      Walls: Drywall
- 4.      Floor: Carpet Carpet stains noted
- 5.      Floor Drain: Surface drain
- 6.      Doors: Hollow wood
- 7.      Windows: Vinyl casement
- 8.      Electrical: 110 VAC Loose junction boxes, missing and mis-sized covers, extension cord wiring to projector

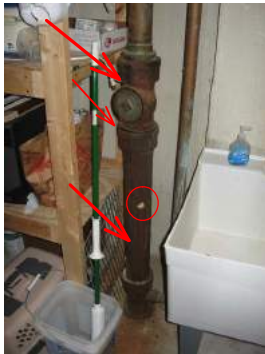
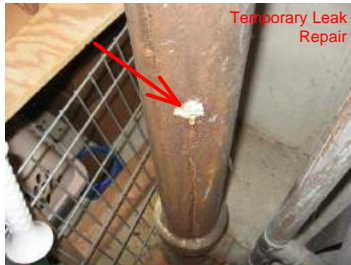
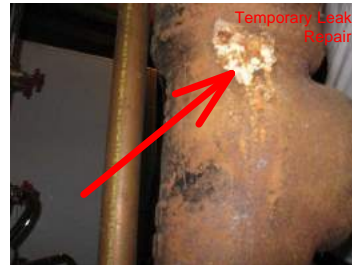
- 1.      Service Line: Copper
- 2.      Main Water Shutoff: Basement
- 3.      Water Lines: Copper
- 4.      Drain Pipes: Cast iron, Copper **Pitting cast iron drain piping stack - replace affected sections where required**

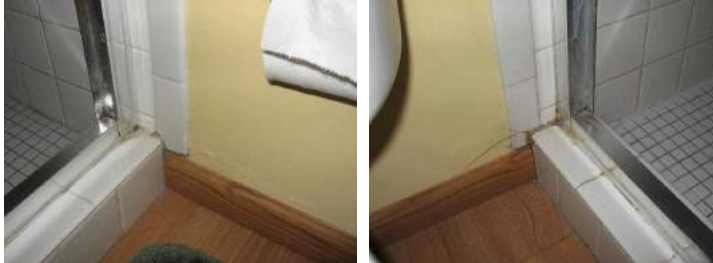
1.      Ceiling: Drywall  
2.      Walls: Drywall  
3.      Floor: Laminated flooring **Gapping noted in planks**  
4.      Doors: Hollow wood  
5.      Windows: Vinyl Insulated  
6.      Electrical: GFCI  
7.      Counter/Cabinet: Wood  
8.      Sink/Basin: One piece sink/counter top  
9.      Faucets/Traps: Delta  
10.      Shower/Surround: Ceramic tile **Leaking at corner of door frame**

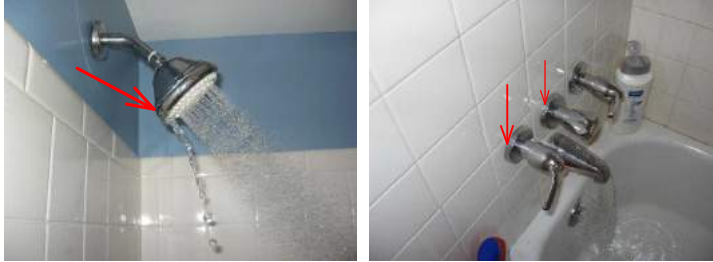
23.      Faucets/Traps: Delta fixtures with a metal trap **Leaking shower head, Loose trim rings**

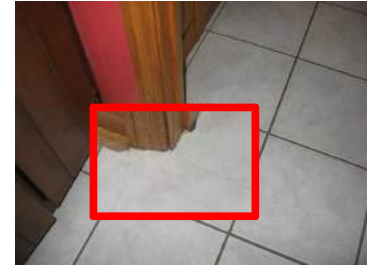
28.      Ceiling: Drywall  
29.      Walls: Drywall  
30.      Floor: Ceramic tile **Cracked tile noted**

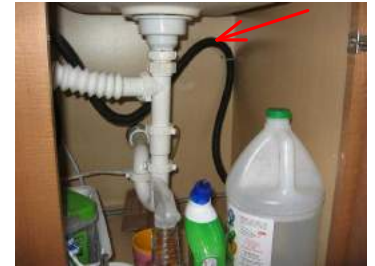
- 1.      Cooking Appliances: Frigidaire
- 2.      Disposal: General Electric
- 3.      Dishwasher: Maytag **Properly secure the dishwasher discharge hose so that it creates a "high loop" above the basin drain to minimize food or water backup under dishwasher**

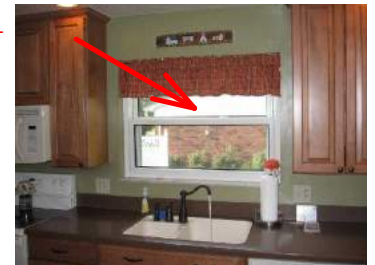
- 4. Air Gap Present?  Yes  No
- 5.      Refrigerator: Amana
- 6.      Microwave: General Electric
- 7.      Sink: Stainless Steel **Chipping at drain**
- 8.      Electrical: 110 VAC GFCI
- 9.      Plumbing/Fixtures: Stainless Steel
- 10.      Counter Tops: Solid Surface
- 11.      Cabinets: Wood Loose cabinet door hinges
- 12.      Pantry: Large
- 13.      Ceiling: Drywall
- 14.      Walls: Drywall
- 15.      Floor: Ceramic tile
- 16.      Doors: Hollow wood
- 17.      Windows: Vinyl Insulated **Insulated glass unit seal failure**

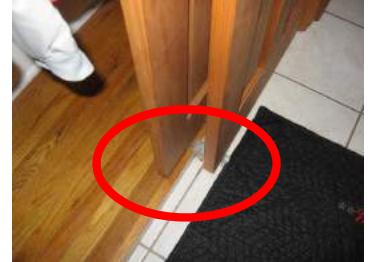
1.      Closet: Various Missing door glides at bypass closet door in Foyer

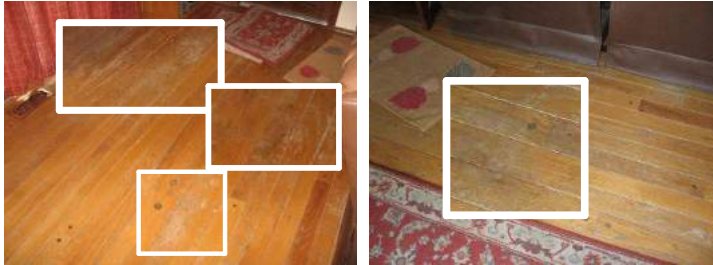
4.      Floor: Ceramic tile, Carpet, Hardwood Worn wood finish in Family room

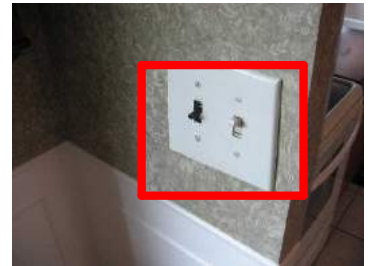
7.      Electrical: 110 VAC Replace missing dimmer switch in Dining room

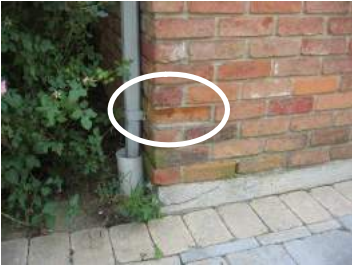
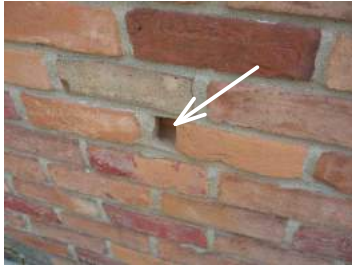
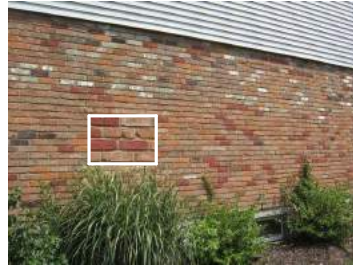
2. 1st Floor Exterior Surface Type: Brick veneer Some damaged bricks, Recommend sealing brick with penetration sealer products

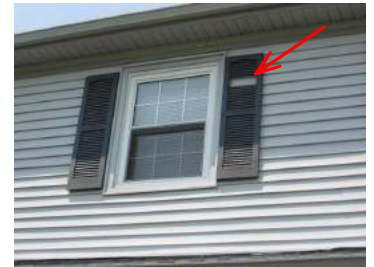
3. 2nd Floor Exterior Surface Type: Vinyl siding Damaged front shutter, Chalking noted due to age, One panel needs to be repositioned at rear elevation

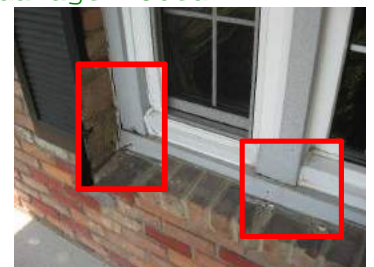
4. Trim: Aluminum Chalking noted due to age, Loose nails in areas
5. Soffits: Vinyl Loose/sagging at front porch
6. Patio Door: Vinyl sliding Resecure loose handle hardware, Screen damage noted
7. Windows: Vinyl insulated Reseal caulking at window perimeters at brick window openings

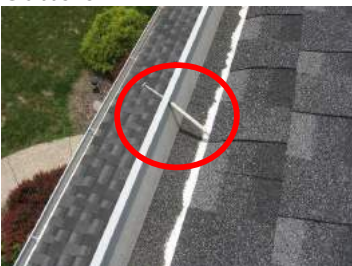
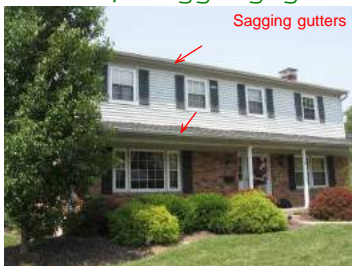
9. Gutters: Aluminum Loose nails, Sagging gutters at front and rear

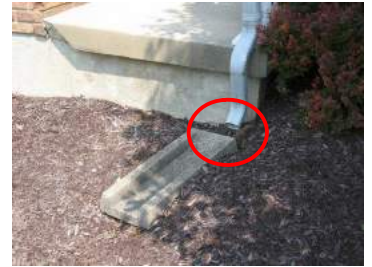
10. Leader/Extension: Splash blocks Splash block(s) not properly installed

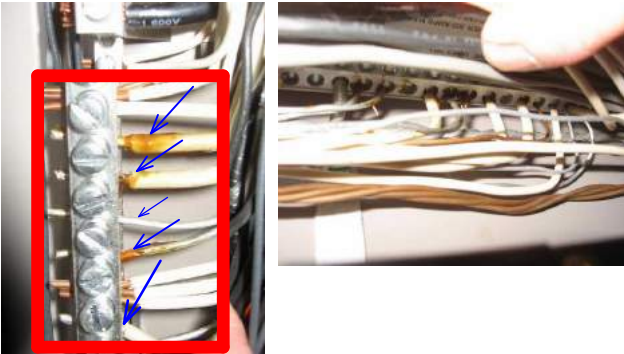
14. 120 VAC Branch Circuits: Copper and aluminum Evaluation by a licensed electrician is recommended, See aluminum wiring notes below  
15. Aluminum Wiring: Present at several circuits Aluminum branch wiring has had a history of problems relating to poor connections due to galvanic corrosion, dissimilar metals, brittle conductors and type of aluminum alloy used during the time period of 1965 through 1972. These problems create unsatisfactory conditions at connections and splice locations and therefore create potential fire hazards. Recommend wiring update for aluminum wiring by a licensed electrician, Circuits are recommended to be upgraded with special compression type connectors at splices and branch circuits to reduce the potential risks of aluminum branch wiring. (Cop-Alum Crimp System)

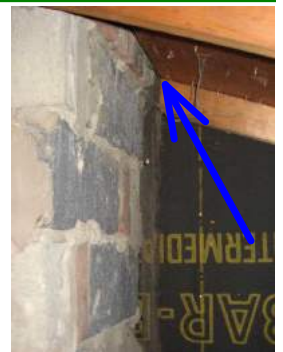
16. Attached Garage Attic Roof Framing: 2x3/4 Truss Wood blocking components missing at chimney perimeter

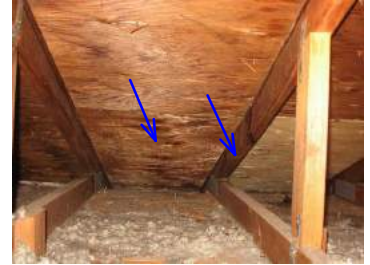
17. Attached Garage Attic Sheathing: Plywood Water stains and slight damage present, Areas of sheathing have been repaired

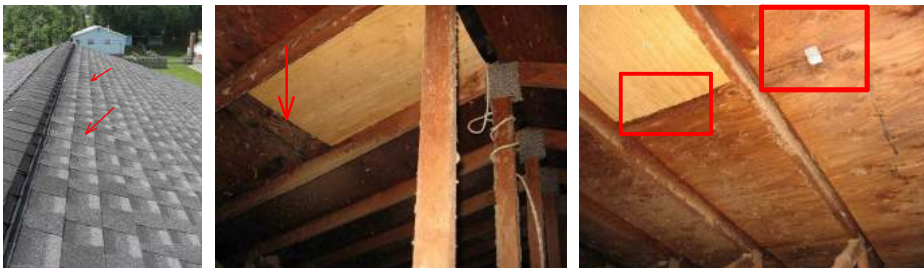
18. Main Attic Sheathing: Plywood Poor repair at 2 areas near ridge at rear slope - No H clips installed and repair only spanned one truss - Recommend additional support be installed

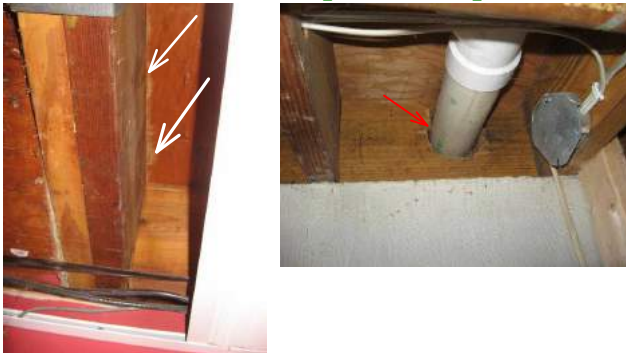
19. Joists/Trusses: 2x10 Areas not visible due to ceiling finishes or other obstructions, Framing joist near fireplace chimney shows evidence of previous termite infestation - No repairs required, Seal penetration as required

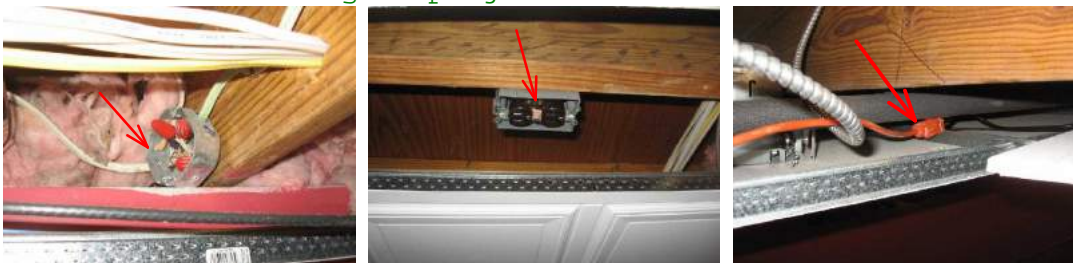
20. Main Basement Floor: Carpet Carpet stains noted  
21. Main Basement Electrical: 110 VAC Loose junction boxes, missing and mis-sized covers, extension cord wiring to projector

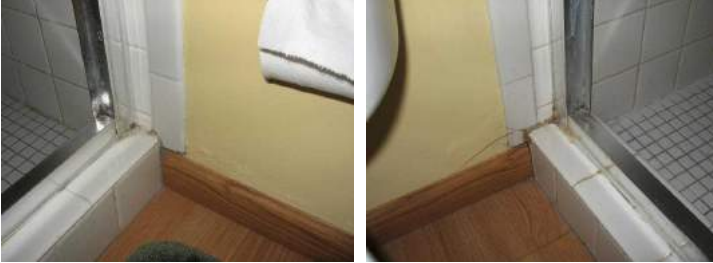
- 22. Master Bathroom Floor: Laminated flooring Gapping noted in planks
- 23. Master Bathroom Shower/Surround: Ceramic tile Leaking at corner of door frame

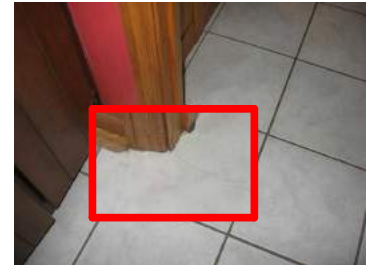
- 24. 2nd Floor Hall Bathroom Closet: Large Alignment needed at closet doors
- 25. 2nd Floor Hall Bathroom Floor: Laminated flooring Gapping noted in planks
- 26. 1st Floor Hall Half Bathroom Floor: Ceramic tile Cracked tile noted

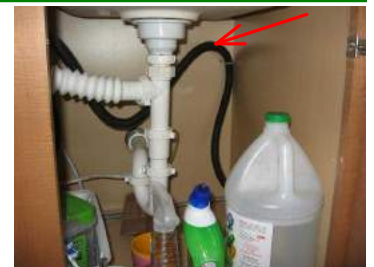
- 27. 1st Floor Kitchen Dishwasher: Maytag Properly secure the dishwasher discharge hose so that it creates a "high loop" above the basin drain to minimize food or water backup under dishwasher

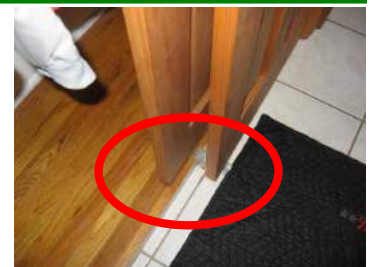
- 29. 1st Floor Living Space Closet: Various Missing door glides at bypass closet door in Foyer

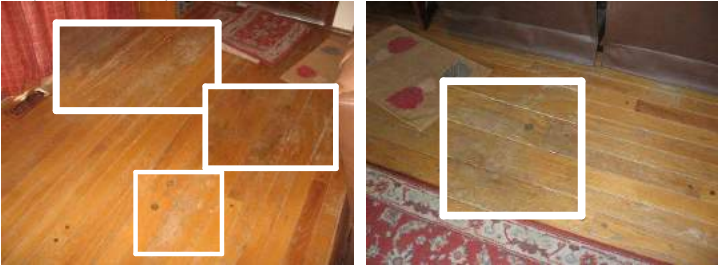
- 30. 1st Floor Living Space Floor: Ceramic tile, Carpet, Hardwood Worn wood finish in Family room

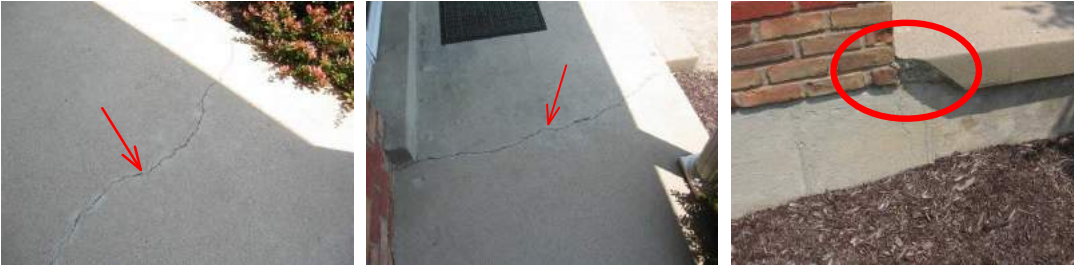
1. Porch: Concrete **Settling away from foundation with surface cracks noted**

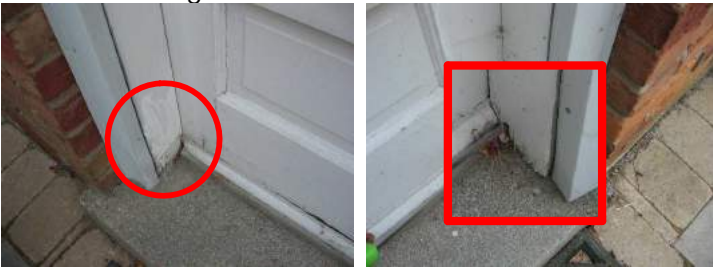
2. Attached Garage Service Doors: wood **Wood rot at bottom of door and frame**

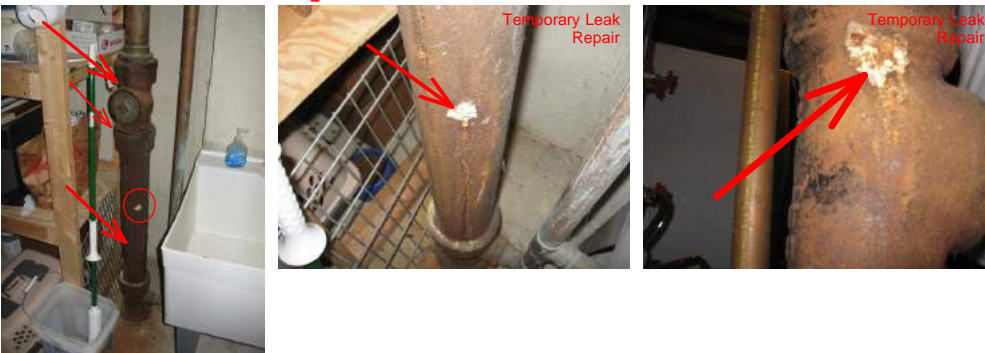
4. Drain Pipes: Cast iron, Copper **Pitting cast iron drain piping stack - replace affected sections where required**

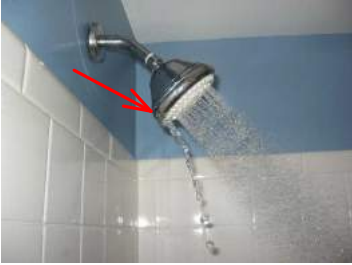
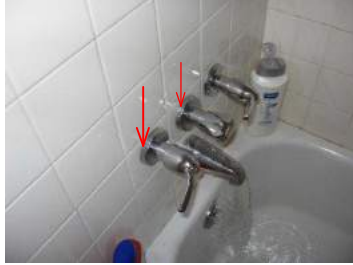
5. 2nd Floor Hall Bathroom Faucets/Traps: Delta fixtures with a metal trap **Leaking shower head, Loose trim rings**

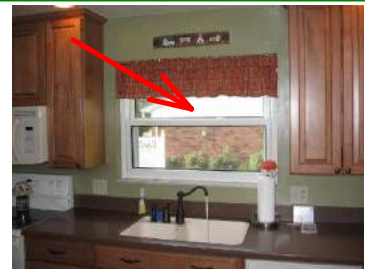
6. 1st Floor Kitchen Windows: Vinyl Insulated Insulated glass unit seal failure
