# Your Personal Home Inspection

123 Somewhere Street  
Yourtown, US 12345

Prepared for: Bob Client

Prepared by: Downriver Home Inspections  
1234 Company Lane  
Somewhere, US 12345

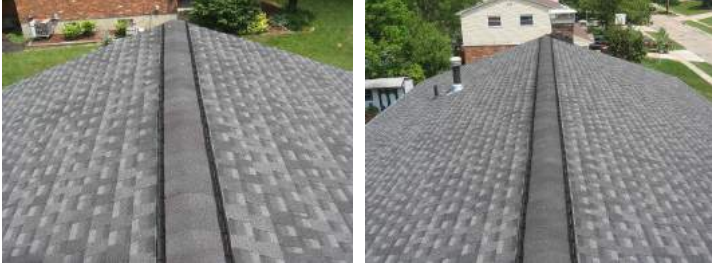
1. Method of Inspection: On roof

- 2.      Unable to Inspect: 0%
- 3.      Material: Fiberglass shingle
- 4. Type: Gable
- 5. Approximate Age: 5
- 6.      Flashing: Metal
- 7.      Plumbing Vents: Copper
- 8.      Electrical Mast: Underground utilities
- 9.      Gutters: Aluminum **Loose nails, Sagging gutters at front and rear**

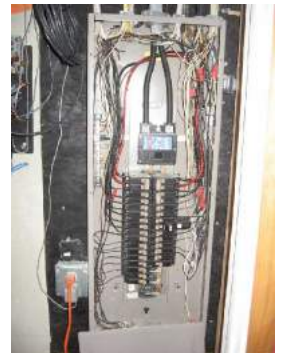
Basement Electric Panel

10. Maximum Capacity: 200 Amps
11.      Main Breaker Size: 200 Amps
12.      Breakers: Copper
13.      AFCI: 110 volt
14.      GFCI: Present

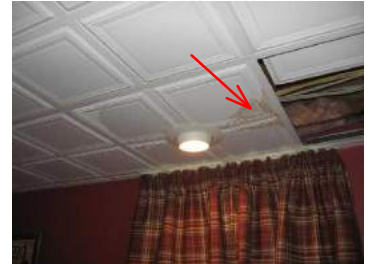
### Main Basement

- 2.      Ceiling: Suspended Acoustical System Evidence of past water staining
- 3.      Walls: Drywall
- 4.      Floor: Carpet Carpet stains noted
- 5.      Floor Drain: Surface drain
- 6.      Doors: Hollow wood
- 7.      Windows: Vinyl casement
- 8.      Electrical: 110 VAC Loose junction boxes, missing and mis-sized covers, extension cord wiring to projector

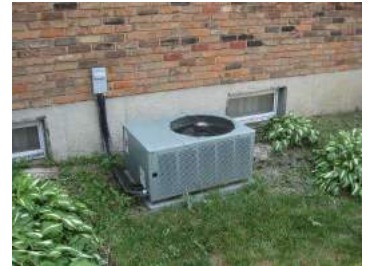
### Main AC System

- 4. Manufacturer: Rheem
- 5. Area Served: whole house Approximate Age: 7
- 6. Fuel Type: 110 VAC Temperature Differential: 16 degrees
- 7. Type: Central A/C Capacity: 3 Ton
- 8.      Visible Coil: Copper core with aluminum fins
- 9.      Refrigerant Lines: Serviceable condition
- 10.      Electrical Disconnect: Breaker disconnect
- 11.      Exposed Ductwork: Metal
- 12.      Blower Fan/Filters: Direct drive with electronic filter
- 13.      Thermostats: Single Zone

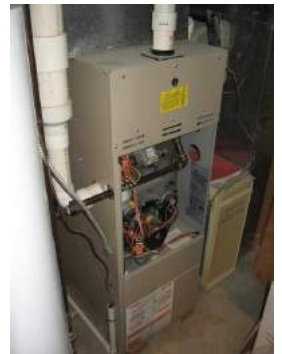
### Basement Heating System

- 2. Manufacturer: Ducane
- 3. Type: Forced air Capacity: 100,000 BTUHR
- 4. Area Served: whole house Approximate Age: 6
- 5. Fuel Type: Natural gas
- 6.      Heat Exchanger: 5 Burner
- 7. Unable to Inspect: 20%
